LOUISIANA DEPARTMENT OF WILDLIFE & FISHERIES

WATERBODY MANAGEMENT PLAN SERIES

SPANISH LAKE

**AQUATIC VEGETATION TYPE MAPS
AND NARRATIVES**

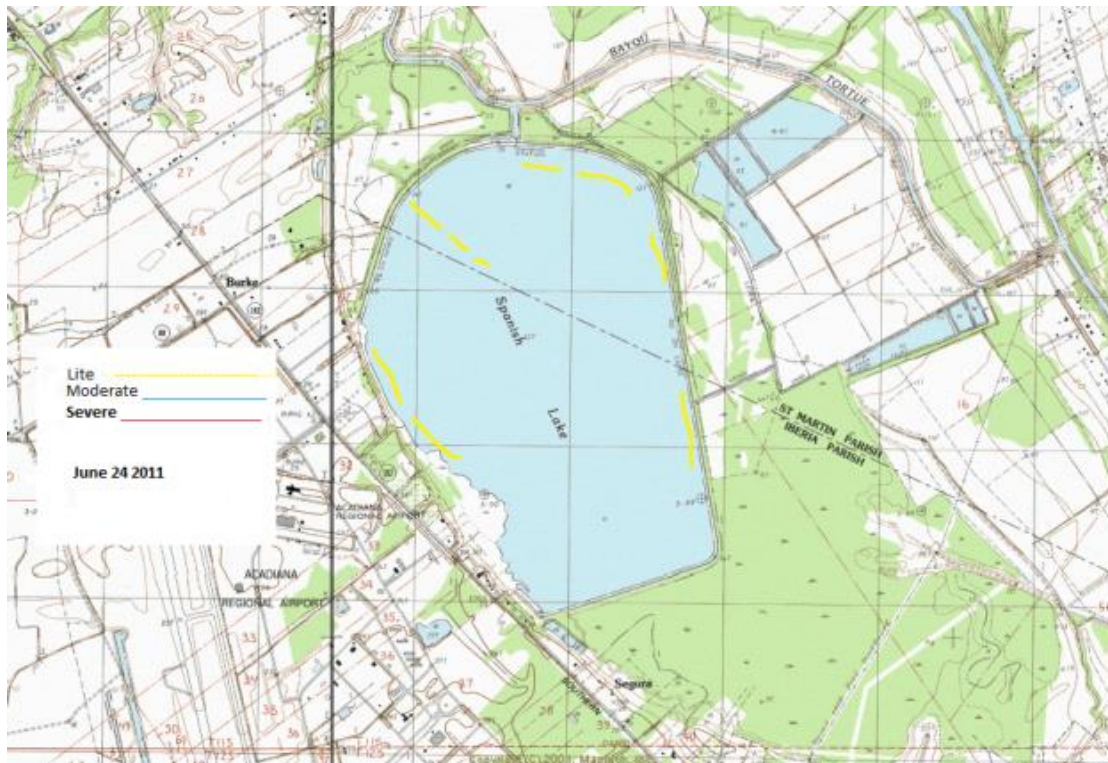
Spanish Lake Vegetation Survey 6-24-2011 - Martin Plonsky

A vegetative type map of Spanish Lake was conducted in June of 2011. Small amounts of vegetation exist in the lake as shown in the type map description. The spray crews did not have to apply herbicide on the lake in 2011.

A survey of aquatic vegetation found in Spanish Lake resulted in the conclusion that there is little to no aquatic vegetation in the lake. Very thin amounts of water hyacinth were observed in the vicinity of the boat launch and on the shoreline of the breakwater islands on the eastern side of the lake. The lake water was saturated (“bloom” condition) with planktonic algae and water ph was above 8.0. Small bunches of iris were seen growing along the eastern bank of the lake. Average water depth was 2 feet. The vegetation survey was conducted on the same day we investigated the report of a fish kill at the lake. No dead fish were observed.
